## HRSG TUBE FAILURE DIAGNOSTIC GUIDE

### 6.3 LP Feedwater Tube #2 Case Study

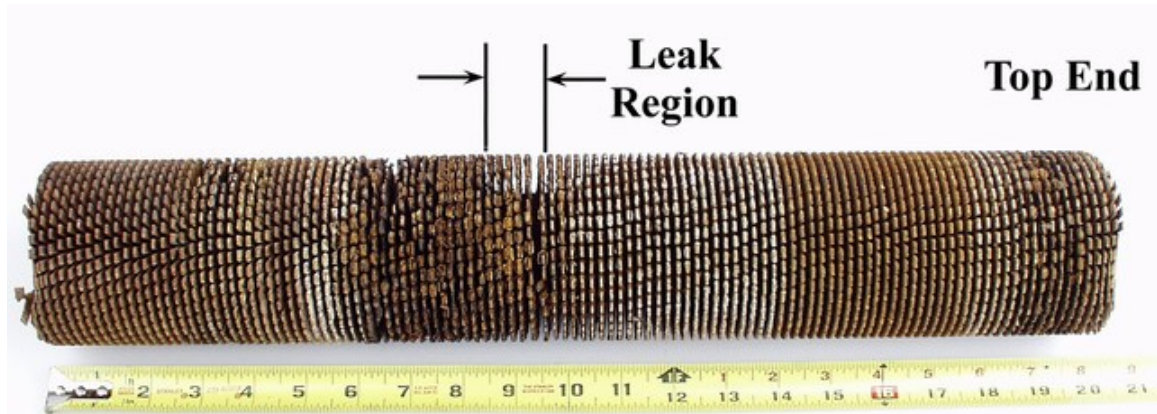
Figure 6-22 Exterior Surface of Tube

Figure 6-22 shows an exterior view of the specimen as-received. The leak region is identified immediately below an area of white deposits on the fins. The fins in the leak region are heavily corroded. Figure 6-23 shows a close up of the leak region. Extensive fin corrosion can be clearly seen.
